New Mexico Plant Materials Center Los Lunas, New Mexico

2001 Progress Report Demonstration Planting

**El Pueblo Acequia, Pecos River
San Miguel County, New Mexico**

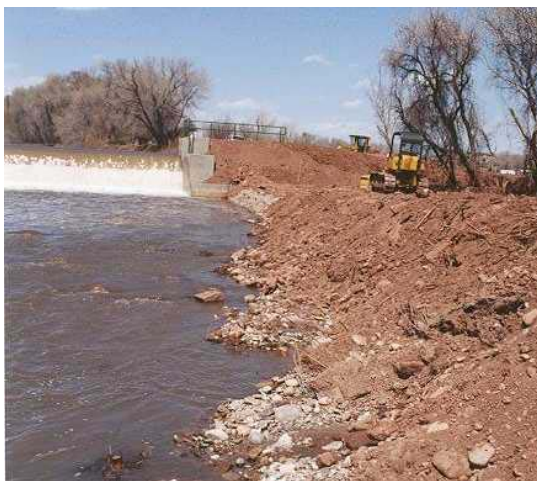
**Riverbank at the base of diversion dam near
El Pueblo, NM**

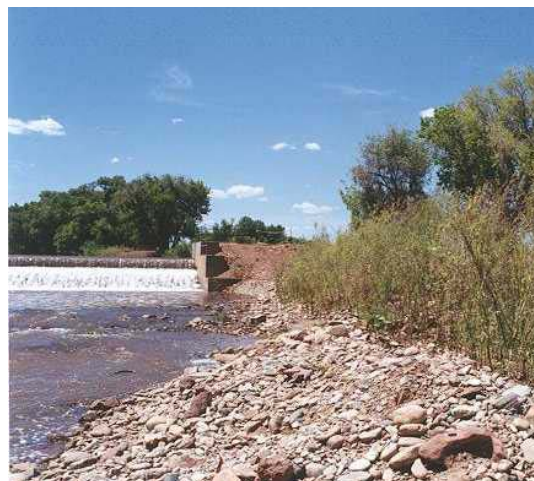
**Same location three months after planting
coyote willow poles (June 2001)**

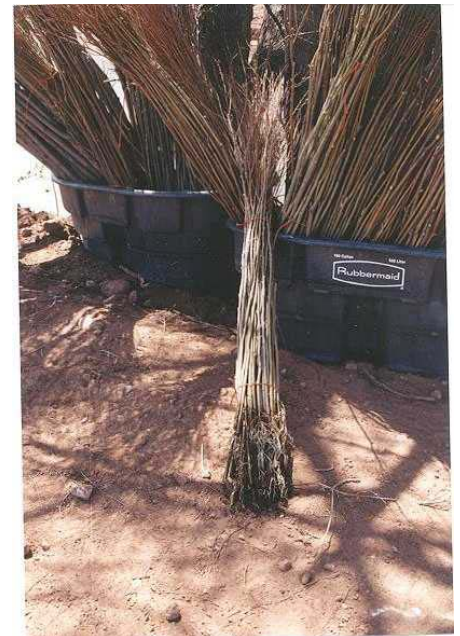
The planting was delayed by two weeks so the dam could be completed. During the time of the delay, the willow pole cuttings began to grow roots (see Figure 1) where the cutting was in contact with water. As spring progressed, the air temperature increased which raised the temperature of the water in the tanks and accelerated the rooting process. This process is usually considered undesirable because some of the limited stored energy in the willow stem is utilized for root growth, and the new roots are often rubbed off during the planting process.

Figure 1: Cuttings growing in water tanks.

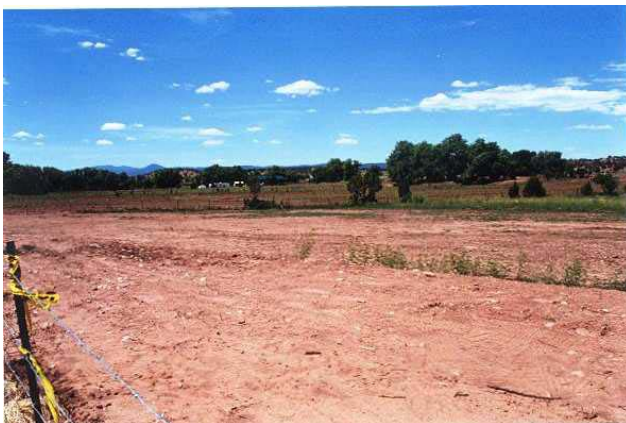
The site where the 60 black willows were to be planted was not ready by April 12. The contractors had not leveled or seeded the site with herbaceous cover, so it was not planted with the willows. The site was leveled and fenced, but there was no evidence of a seeding (see Figure 2). The PMC will plant black willow pole cuttings in February or March of 2002.

Figure 2: Planting location for black willow pole planting.

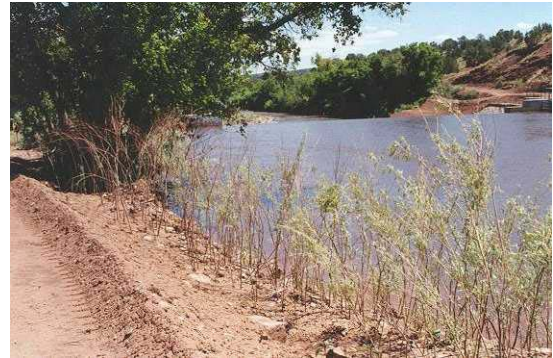
considered dead because they did not have any green leaves. Some willows that were considered dead could possibly resprout at the base during this current growing season. Those that were dead were generally found on the upper slope of the bank where they may have been above the capillary soil moisture from the stream (see Figures 7 and 8).

Figure 7: Willow on the upper bank may have become droughty and died.

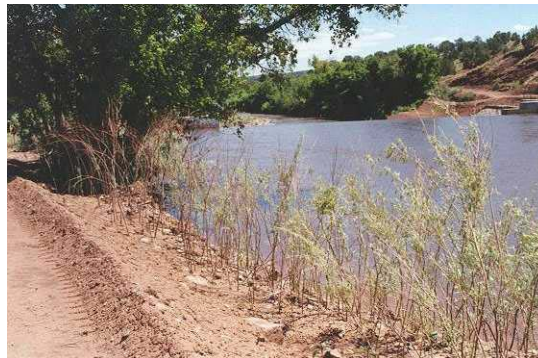
Figure 8: A second location where willow died on the upper bank.
